# Report

## Roadway Corridor Assessment

District of Fort St. James

0728.0007.01 | November 2019

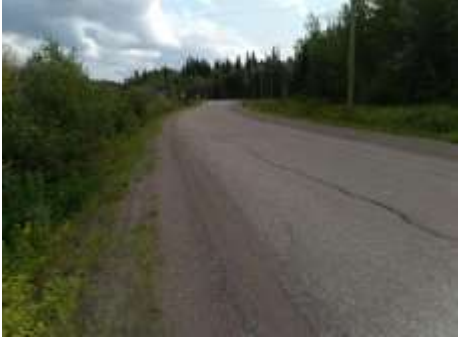
| DISTRESS | IMAGE | CAUSE |
|---|---|---|
| Longitudinal Wheel Path Cracking (LWP) | | <p>Cracks which follow a course predominantly parallel to the pavement centreline and are located at or near the centre of the wheel path.</p> <p>LWP cracking indicate fatigue failure from heavy vehicle loads. Cracks within one foot of the edge are caused by insufficient shoulder support, poor drainage, or frost action.</p> |

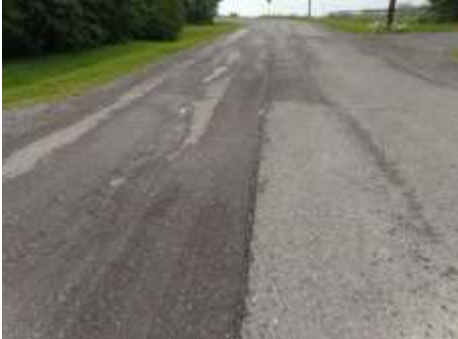
| DISTRESS | IMAGE | CAUSE |
|---|---|---|
| Longitudinal Joint Cracking (LJ) | | <p>Cracks running in the direction of traffic are longitudinal cracks.</p> <p>Centre line or lane cracks are caused by poor construction of longitudinal joint, frost action on adjacent lanes with variable granular depths, differential frost heave along the centreline caused by the insulating value of snow along pavement edges, moisture changes resulting in swelling and shrinkage.</p> |

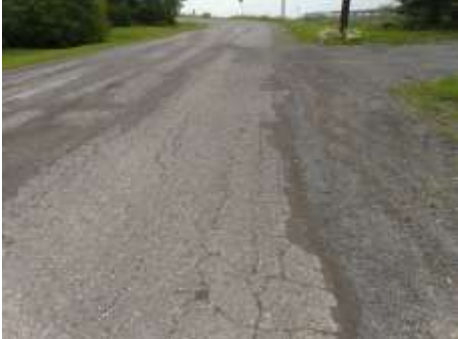
| DISTRESS | IMAGE | CAUSE |
|---|---|---|
| Pavement Edge Cracking (PEC) | | <p>Cracks which occur parallel to and within 0.6 meters of the inside and/or outside of the fog line. Cracks may be crescent shaped cracks or other consistent cracks which intersect the pavement edge.</p> <p>Possible causes include: Frost action, inadequate pavement structural support at the pavement edge and/or excessive traffic loading, poor drainage at the pavement edge and shoulder, inadequate pavement width forces traffic too close to the pavement edge.</p> |

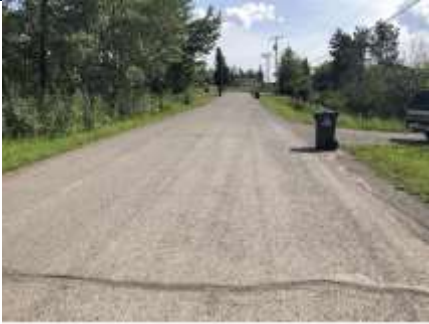
| DISTRESS | IMAGE | CAUSE |
|---|---|---|
| Transverse Cracking (TC) | | <p>Cracks that are predominantly perpendicular to the pavement centreline and may extend fully or partially across the roadway.</p> <p>Possible causes include: surface shrinkage caused by low temperatures, high temperature susceptibility of the asphalt cement binder in asphalt mixes, frost action, reflection cracks and hardening of the asphalt with aging</p> |

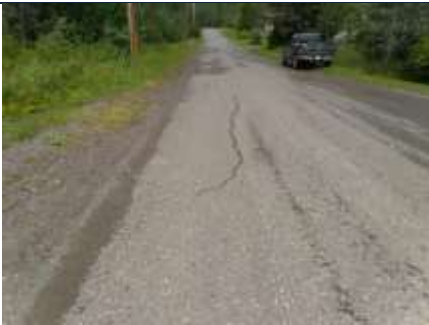
| DISTRESS | IMAGE | CAUSE |
|---|---|---|
| Meandering Longitudinal Cracking (MLJ) | | <p>Cracks which wander from edge to edge of the pavement or run parallel to the centreline, situated near the middle of the lane. MLJ cracks are usually single cracks, but secondary cracks can develop in areas where transverse thermal cracks also exist.</p> <p>Possible causes include: Frost action with greater heave at the pavement centre than at the edges. This is more prevalent in mixes where asphalt stripping is extensive. Faulty construction equipment can cause weak planes in the mix, which can fail from thermal shrinkage</p> |

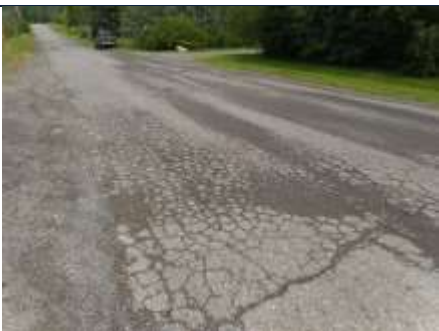
| DISTRESS | IMAGE | CAUSE |
|---|---|---|
| Alligator Cracking (AC) | | <p>Cracks which form a network of multi-sided blocks resembling the skin of an alligator. Block size can range in size which indicates the depth of failure taking place. The pattern of cracking is usually longitudinal, originating in the wheel paths, but can occur transversely due to frost heaves or settlement and along the centreline on narrow two-lane roads.</p> <p>Possible causes include: areas subjected to repeated traffic loadings. Insufficient bearing support due to poor quality base materials or saturated base with poor drainage, stiff or brittle asphalt mixes at cold temperatures.</p> |

In addition to crack sealing, we estimate there is approximately 7,000 m<sup>2</sup> of alligator cracking requires attention. It is important to understand that surface patching of alligator cracking is a temporary fix since alligator cracking is often a sign of failure within the base, subbase, or subgrade; however, patching may lengthen the remaining life of that area temporarily until a proper fix can be completed.

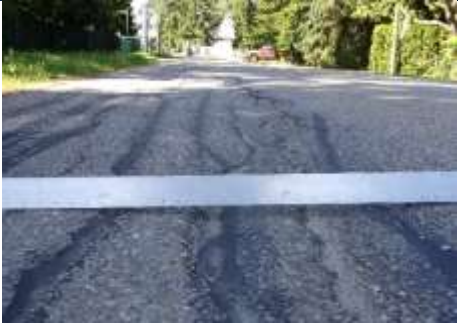
| DISTRESS | IMAGE | CAUSE |
|---|---|---|
| Rutting (RUT)<br><br><i>*Photo not from Fort St. James</i> | | <p>Longitudinal depressions left in the wheel paths after repeated loadings, combined with sideways shoving of the pavement material.</p> <p>Possible causes include: Poorly compacted structural layers, Heavy loadings of saturated unstable granular bases/sub-bases during spring thaw periods, unstable asphalt mixes due to high temperature or low binder viscosity, inadequate lateral support from unstable shoulder materials, permanent deformation of an overstressed subgrade</p> |

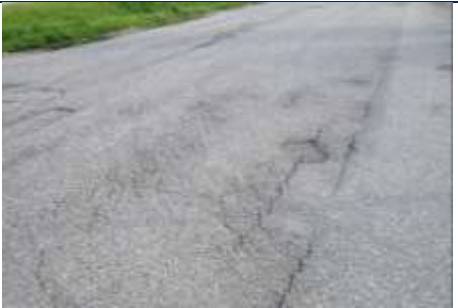
| DISTRESS | IMAGE | CAUSE |
|---|---|---|
| Shoving (SHV)<br><br><i>*Photo not from Fort St. James as shoving was not observed</i> | | <p>Longitudinal displacement of a localized area of the pavement surface generally caused by braking or accelerating vehicles and usually located on hills, curves or intersections.</p> <p>Possible causes include: Heavy traffic on steep downgrades or upgrades, low stability asphalt mix, lack of bond in asphalt surface and underlying layer, unstable granular base.</p> |

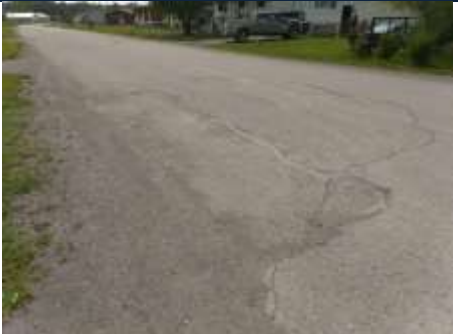
| DISTRESS | IMAGE | CAUSE |
|---|---|---|
| Distortion (DST) | | <p>Any deviation of the pavement surface from its original shape other than that described for shoving and rutting. Generally, distortions result from settlement, slope failure, volume changes due to moisture changes and to frost heaving, and from residual effects of frost heaving accumulating after each season.</p> <p>Possible causes: Differential frost heaves in poorly drained cuts, transitions and at pavement edges or centre. Reverse differential frost heave at culverts, differential settlement of subgrade or base</p> |

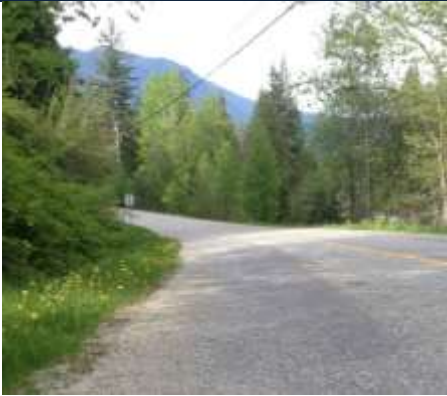
| DISTRESS | IMAGE | CAUSE |
|---|---|---|
| Bleeding (BLD)<br><br><i>*Photo not from Fort St. James as bleeding was not observed</i> | | Excess bituminous binder on the pavement surface can create a shiny, glass-like, reflective surface that may be tacky to the touch. Bleeding quite often occurs in the wheel paths. Possible causes include: Mix design deficiencies where too high an asphalt content relative to voids results in excess asphalt forced to the surface by traffic, especially on hot days, paving over surfaces with severe bleeding or the application of a heavy prime or tack coat under a new pavement layer may result in excess primer bleeding through the pavement surface over a period of time, poor construction of surface seal coats. |

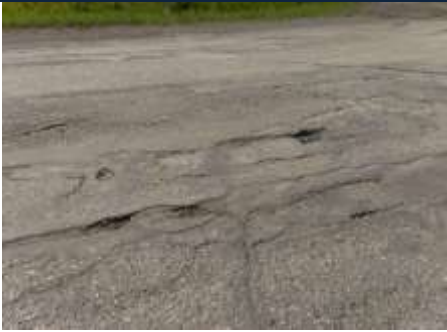
| DISTRESS | IMAGE | CAUSE |
|---|---|---|
| Potholes (POT) | | Bowl-shaped holes of various sizes in the pavement surface.<br><br>Possible causes include: Thin spot in the asphalt layer, localized drainage problems such as water infiltration through poorly bonded pavement structural layers or segregated spots in the asphalt mix where coarse patches allow intrusion of water, asphalt mix design deficiencies. |

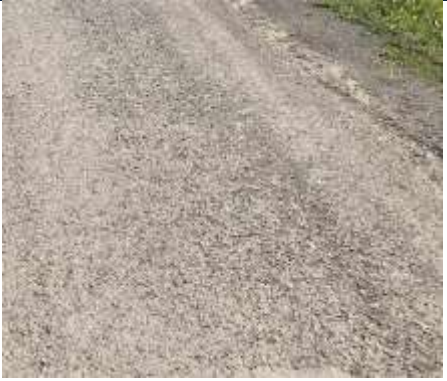
| DISTRESS | IMAGE | CAUSE |
|---|---|---|
| Raveling (RAV) | | The progressive loss of the pavement material from the surface downward, leaving a rough surface, vulnerable to weather deterioration.<br><br>Possible causes include: poor adhesion of aggregates due to insufficient asphalt content, clay-coated aggregate, use of wet aggregates or stripping due to water action, fracture of aggregate particles by heavy loads or natural causes, the unbound particles are then removed by traffic, reducing the depth of the asphalt, poor compaction permits infiltration of water and salts which promote asphalt stripping, |

It was observed that much of the asphalt pavement within Fort St. James is oxidizing and raveling. Raveling is deterioration of pavement by the loss of asphalt and rocks on the surface. If conditions are right and the road is structurally sound, a surface treatment may be a suitable option to mitigate further oxidation and raveling of the pavement. While we have not assessed each road segment for suitability for a surface treatment, we have highlighted roads where raveling is extensive (greater than 50% of the road area) as shown on Map 6. It is recommended the suitability for the various surface treatments on these roads be further reviewed to maximize the roads life before more major rehabilitation works are required.

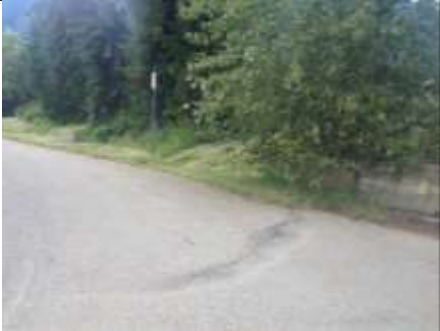
| DISTRESS | IMAGE | CAUSE |
|---|---|---|
| <b>Tree Roots</b><br><br><i>*Photo not from Fort St. James as root problems were not observed</i> | | <p>Surface failures caused by tree roots.</p> <p>Caused by tree roots growing between road base and asphalt surface. The force from the tree roots causes the localized swelling and cracking of the road surface.</p> |

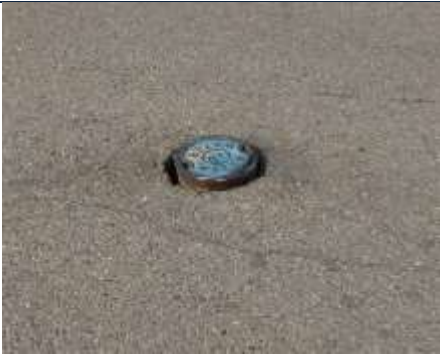
| DISTRESS | IMAGE | CAUSE |
|---|---|---|
| <b>Manholes</b> | | <p>Cracking, swelling or settling of the road surface around manholes, catch basins or other infrastructure within the road surface.</p> <p>Possible causes include: poor compaction of materials around manholes, low spot or inadequate drainage allowing water to pool and weaken surface and surrounding base materials.</p> |

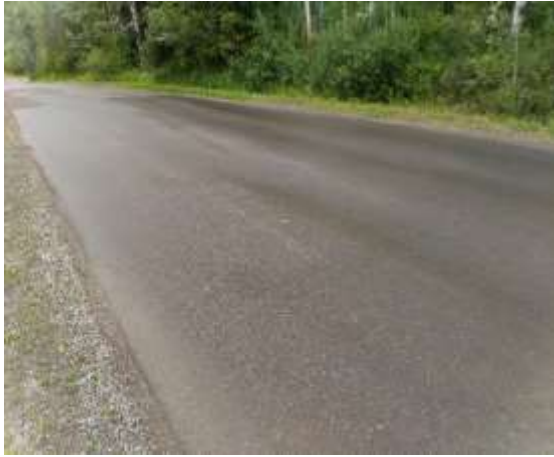
**Figure 3: Examples of the Condition of Patching and Crack Sealing**

Level 3 Patch - In good condition

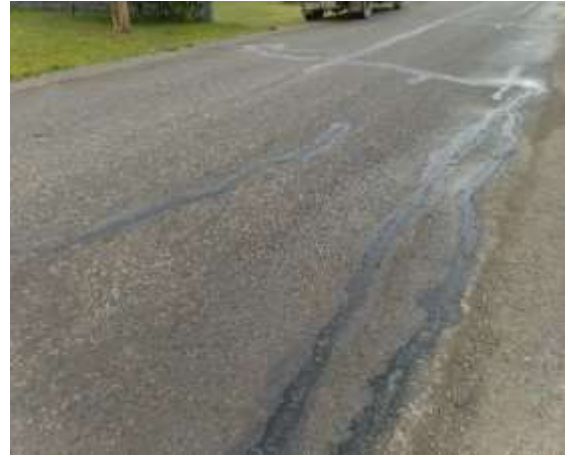
Level 3 crack seal condition

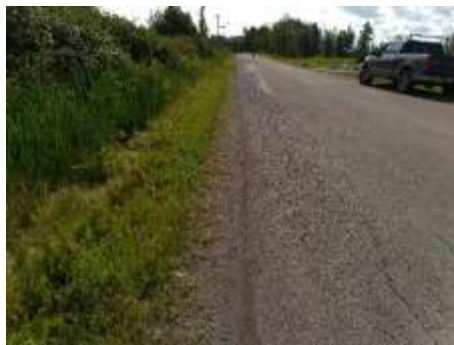
**Figure 4: Examples of the Drainage Issues Found During the RCA**

Examples of some of the drainage issues found during the RCA are shown in Figure 7. It should be noted that signs of road base failure were often found where drainage issues were observed.

**Ditch Vegetation and Ponding Water –  
Stones Bay Rd near Golf Course**

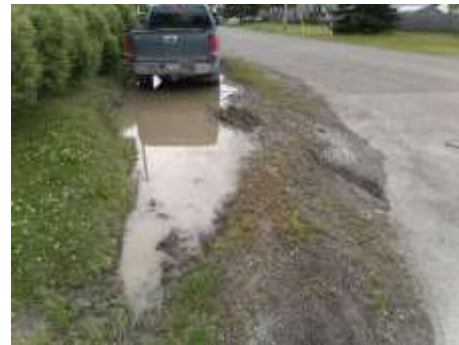
**Low Spot – 2 Ave W and Elm St W**

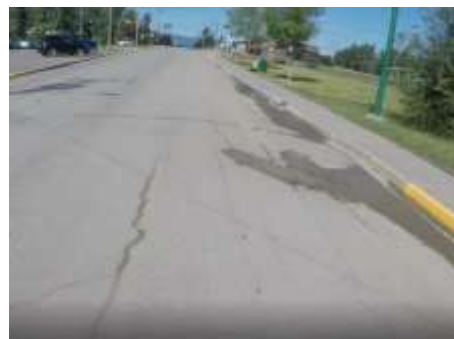
**Inadequate Drainage – Stuart Drive E  
Near Curling Rink**

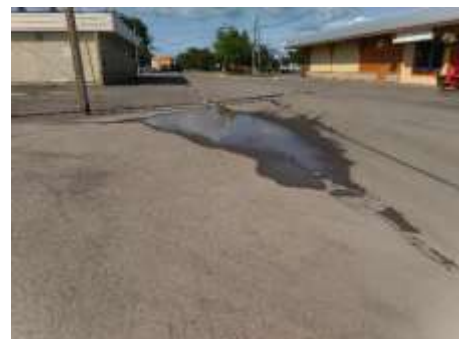
**Surface Low Spot - Mason Street –**

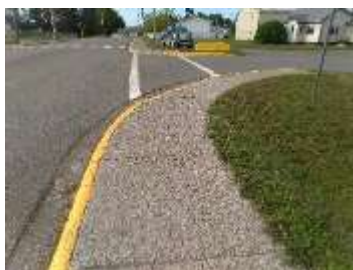
**Figure 5: Examples of the Sidewalk Distresses Found During the RCA**

**Sidewalk scaling –  
Douglas Avenue**

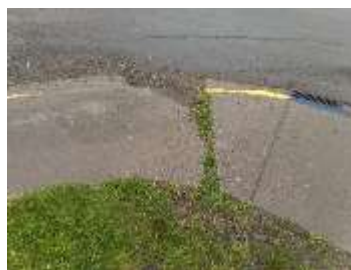
**Tripping Hazards  
– Stuart Drive E**

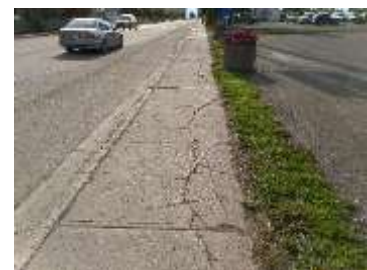
**Sidewalk Cracking  
– Stuart Drive W**

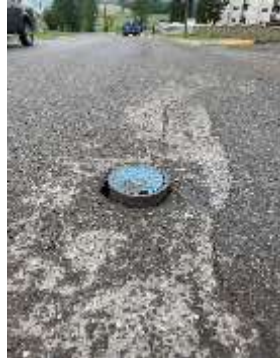
**Figure 6: Safety Concerns Found During the RCA**

There were no major safety concerns requiring immediate attention related to road surface condition that were noted during the RCA. However, one concern noted is the valve box within Stuart Drive E near Eagle Court. The valve box is protruding above the road surface, and there is a visible void forming around the valve box and under the pavement. It is recommended this be investigated and repaired accordingly to avoid a potential larger problem.

**Protruding Valve Box and Loss of Surrounding Material – Stuart Drive E and Eagle Court**

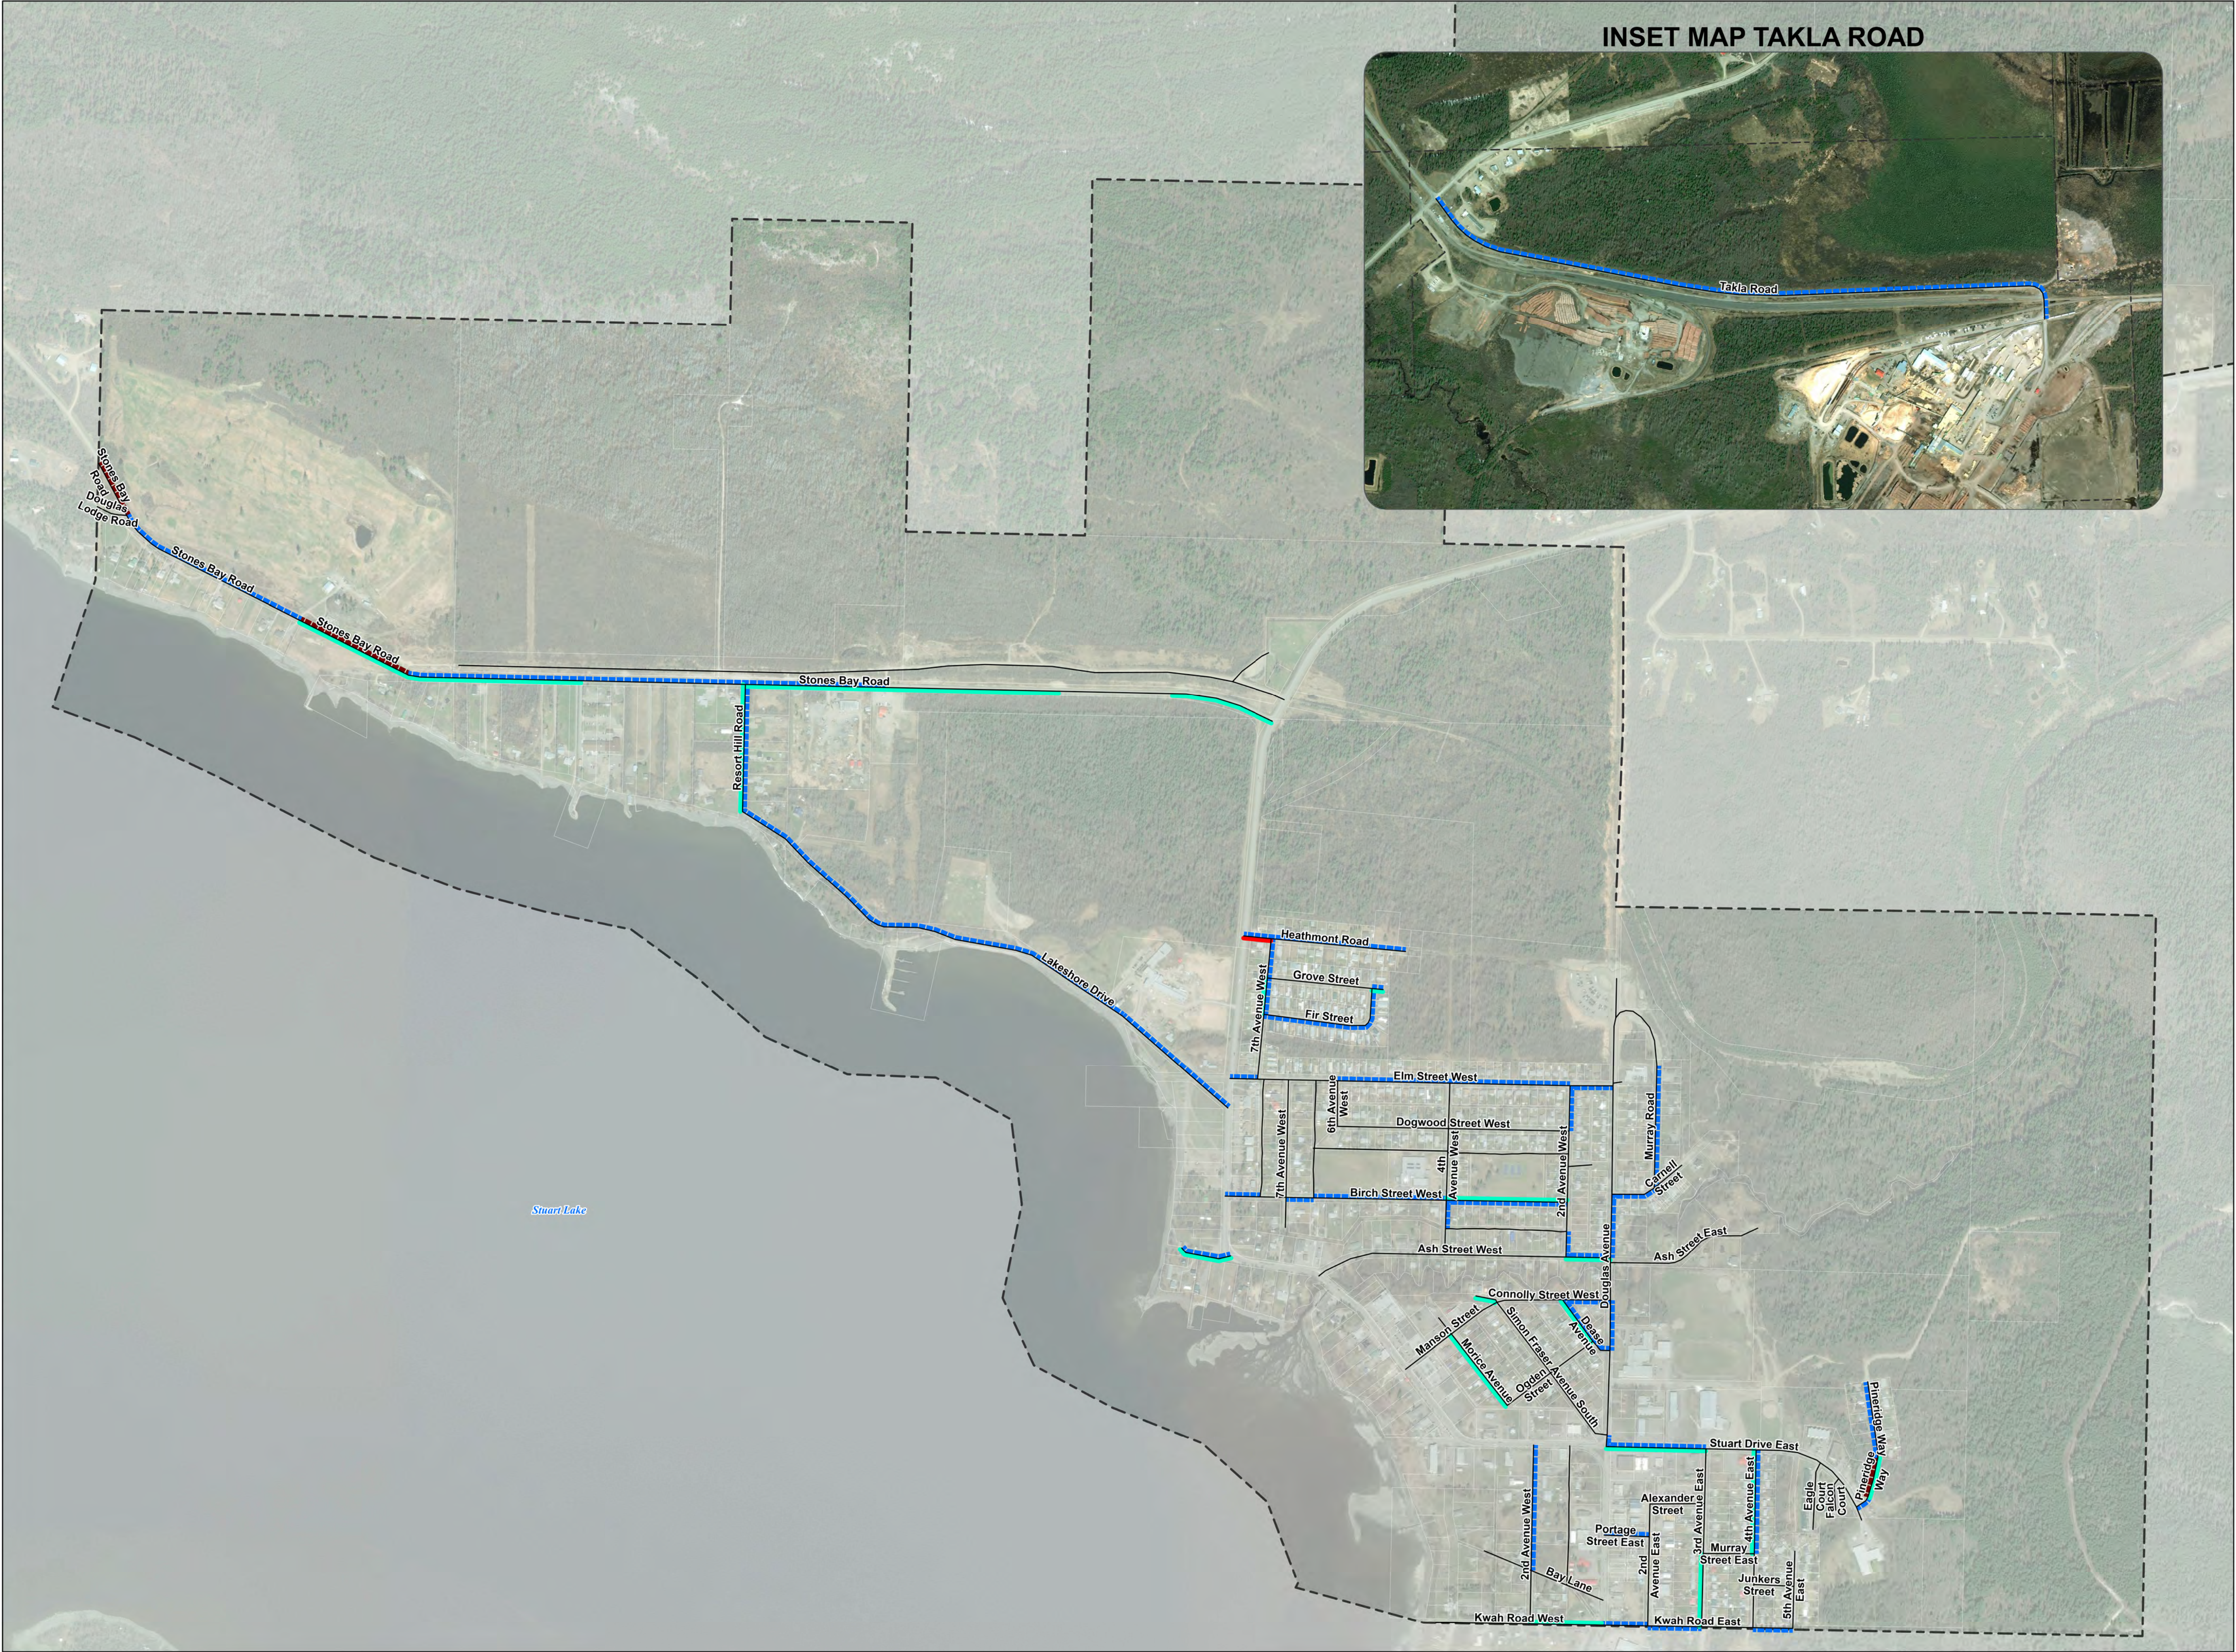
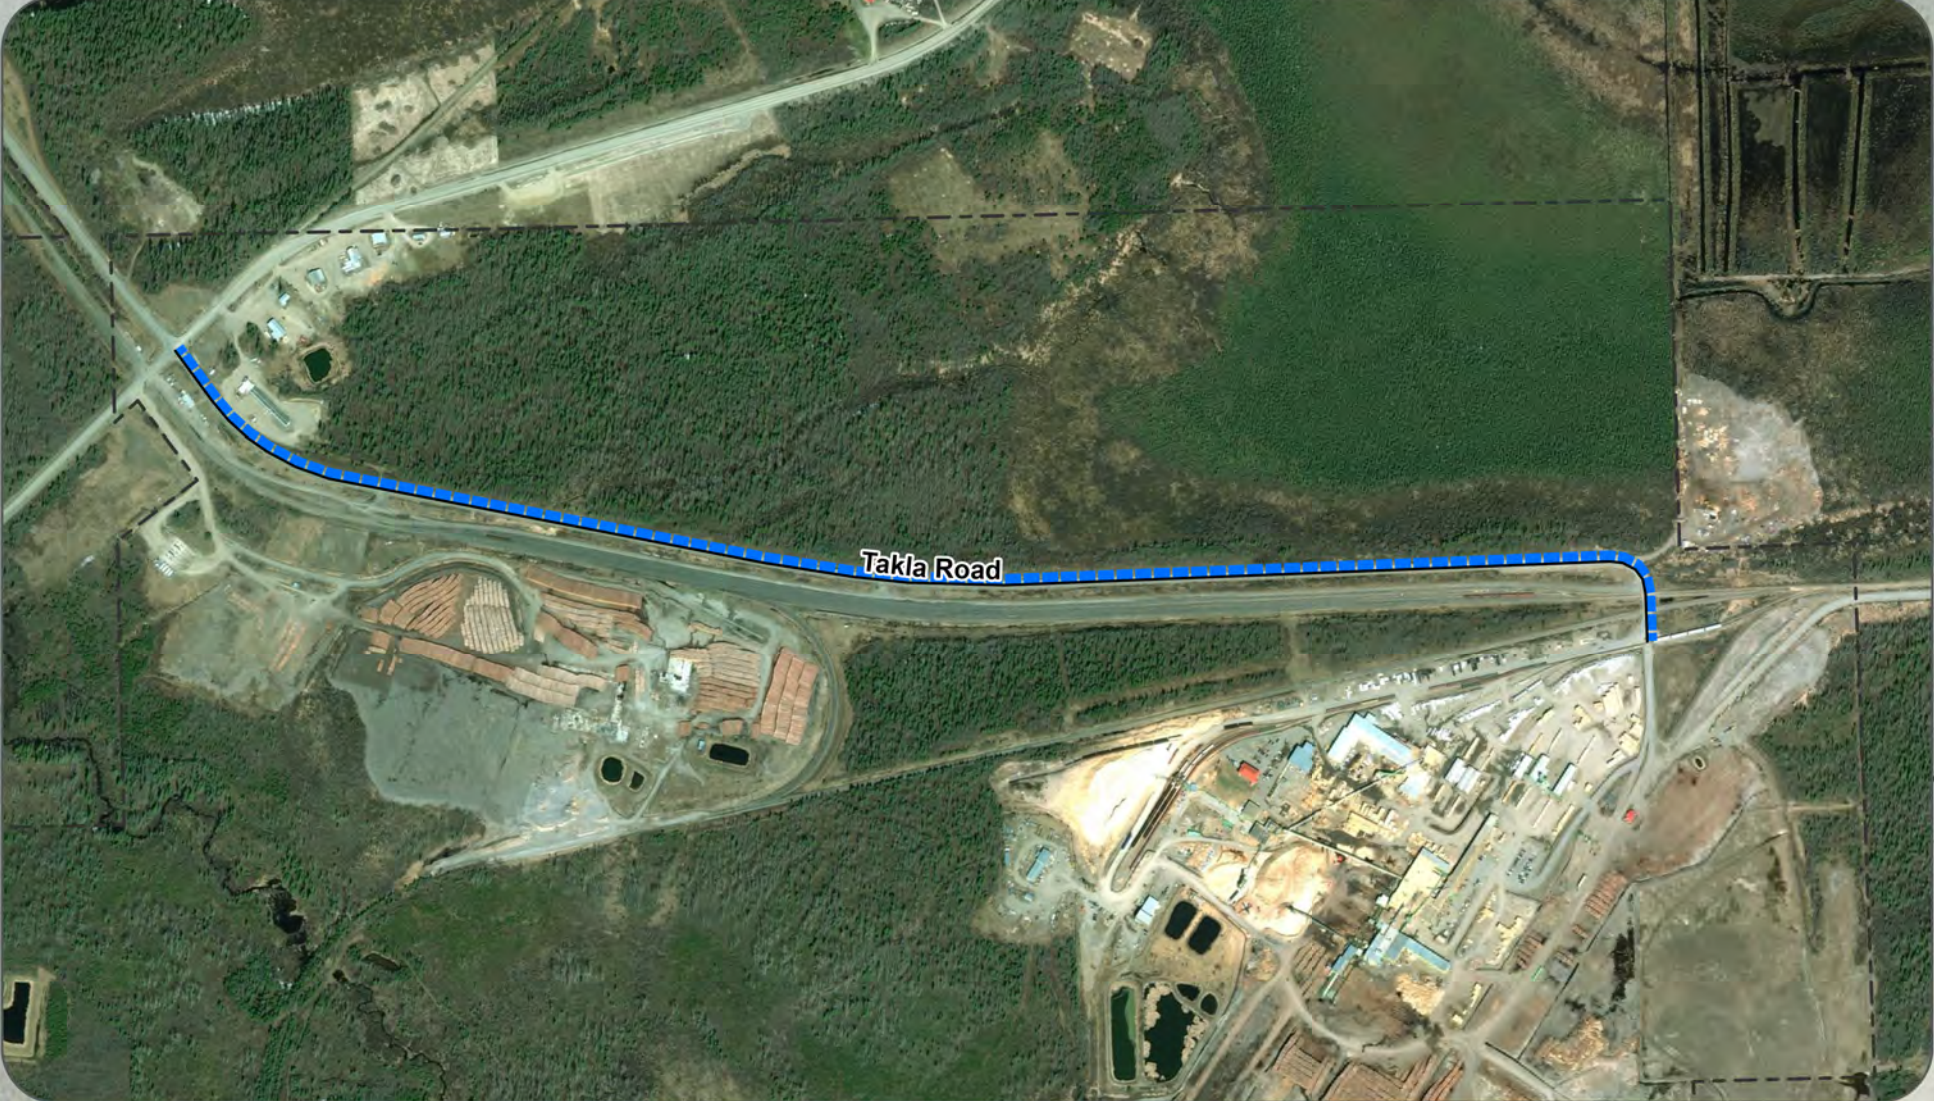
| Date: | 2019 / 9 / 26 | FIGURE 5.0 |

Road Surface with High Severity  
Distresses Indicating Potential  
Base Failure

During the RCA, roads that appeared to show signs of base failure were flagged for further review. Map 5 shows the result of the RCA and the roads with distresses indicating potential base failure. The distresses noted include:

- High severity longitudinal wheel path cracking;
- High severity distortion;
- High severity rutting;
- High severity pavement edge cracking;
- Alligator cracking.
